PROJECT SUMMARY

**Report No. FHWA-SC-12-02
May 2012**

Field Evaluation of Temperature Differential in HMA Mixtures

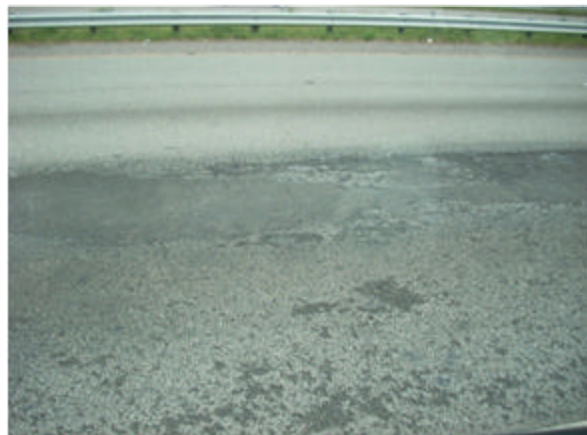
Severe Raveling on OGFC After 42 Months

Open Graded Friction Course (OGFC) however, can be severely affected by thermal segregation, and damage can appear in as little as six months from the time of construction. The data does not indicate a specific correlation between temperature at construction and the time until temperature differential damage becomes apparent, however locations that are most susceptible to premature distress (in the form of severe raveling) are start-up areas after cold paving joints and areas adjacent to bridge decks. These areas are subject to greater cooling due to the extra hand working and roller delays necessary to achieve a smooth transition in these areas.
